Logitech WiLife and LukWerks Outdoor Security Camera Capacitor replacement

The most common cause of failure for this camera is four faulty capacitors. Replacing the damaged capacitors can restore proper function.

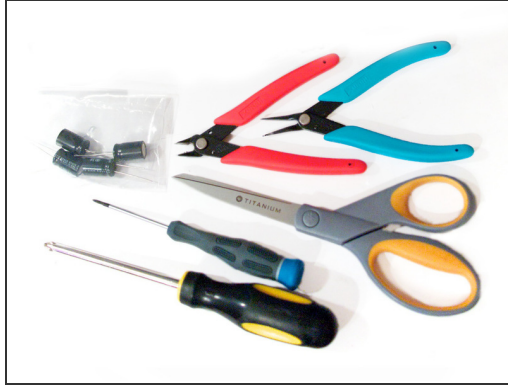
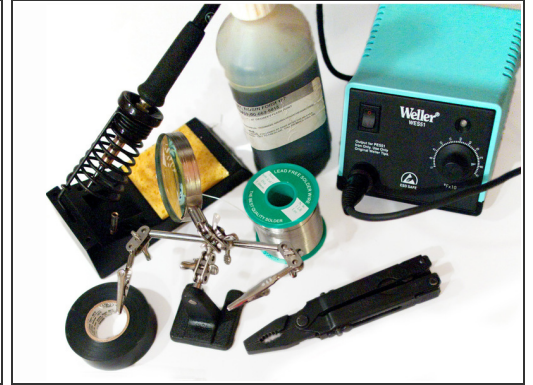
Step 1 — Capacitors

- Obtain (4) 1000uF capacitors rated for 25 volts. The replacement capacitors featured in this guide were purchased from Digi-key. Digi-key part number: UHE1E102MHD6.
<http://search.digikey.com/scripts/DkSear...>
- Additional suggested tools for this repair are pictured.

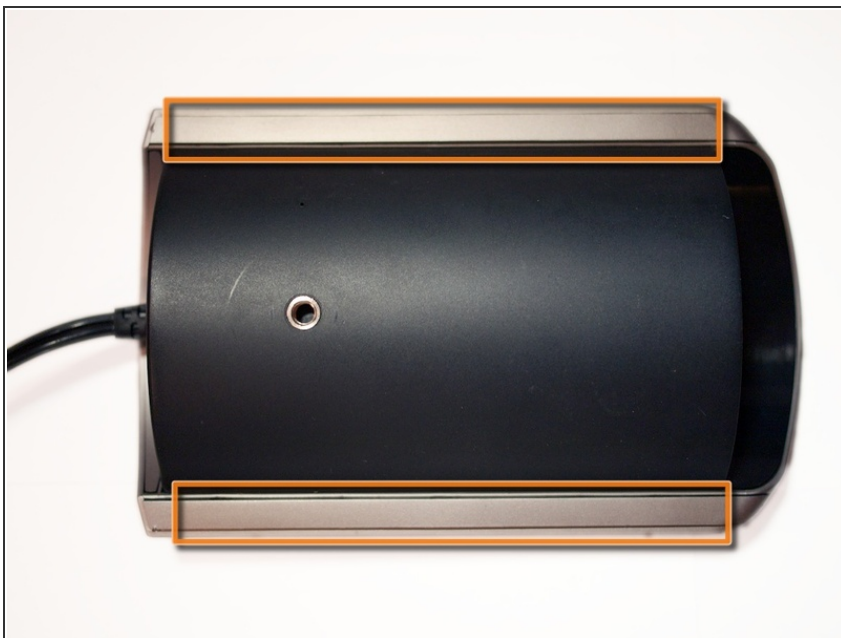
Step 2

- **Caution: Be mindful of the dangerous high voltage that exist in this device when powered and for a short time afterward.**
- Place the camera upside down.
- Using a small flat tool, pry off the plastic covers on each side of the case (outlined in orange)

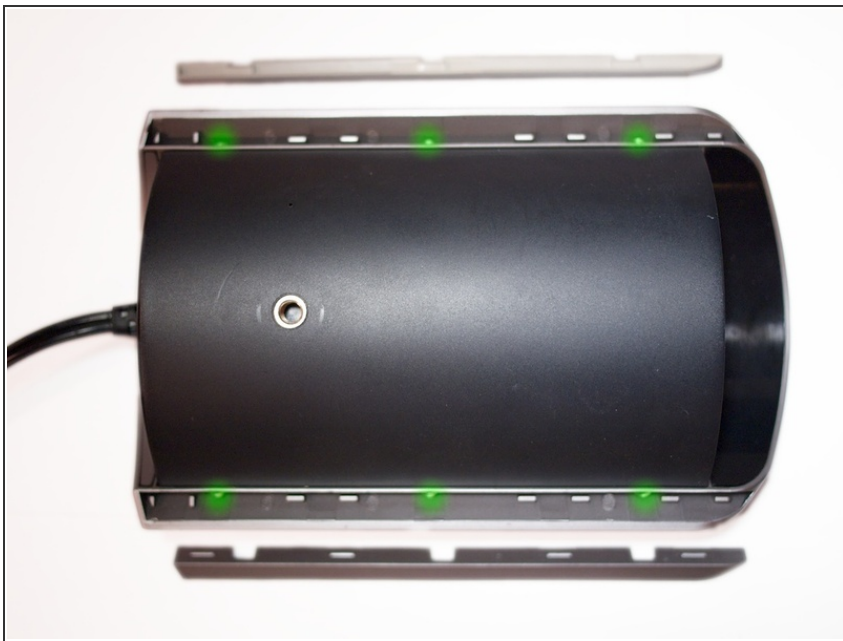
Step 3

- Removal of the covers reveal six philips head screws (green highlight).
- Unscrew all six screws.

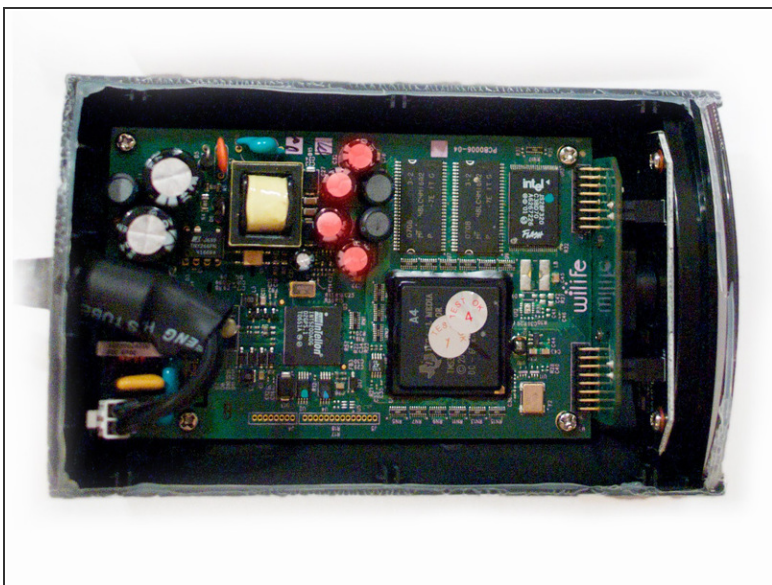
Step 4

- Flip the camera so the top is right-side up.
- Remove the top of the case.
- Notice the four damaged capacitors C26, C27, C31 and C32 (red highlight).

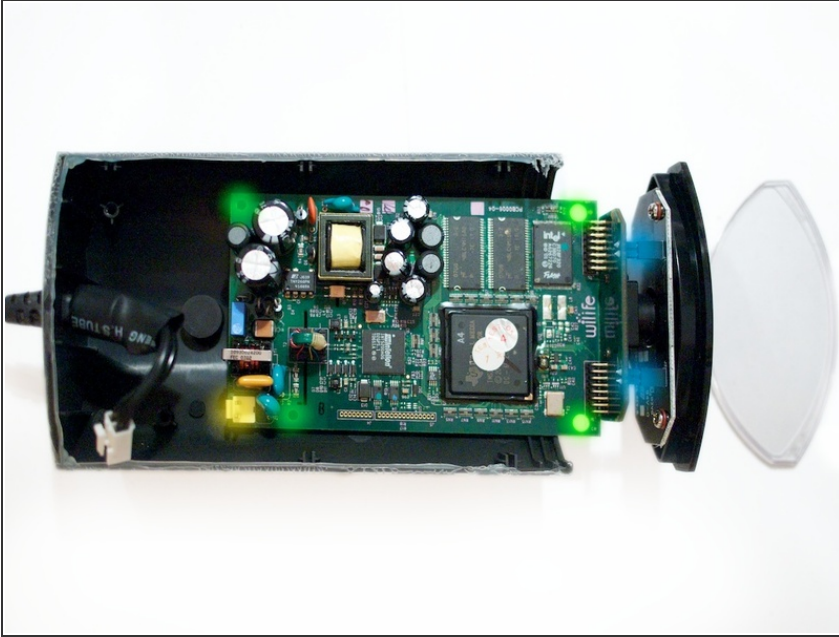
Step 5

- Unscrew all four phillips head screws in each corner (green highlight).
- Disconnect power cable (yellow highlight).
- Lift and remove the clear front plastic lens cover.
- Lift the circuit board and camera assembly out of the case.
- Carefully separate the LED assembly from the four small connectors (highlighted in blue).
Note: This step is not required for this repair. However, it reduces the possibility of inadvertent damage during the process.
